Manhole Inspection Summary

Manhole # S04II2025MH

Record Plat: **04II2** Node: **025** Status: **New Manhole (Not in GIS)** Insp Date: **7/19/06 12:00 AM**

Location Address: **3106 SHELBURNE RD** Cross Street: **LABYRINTH RD**

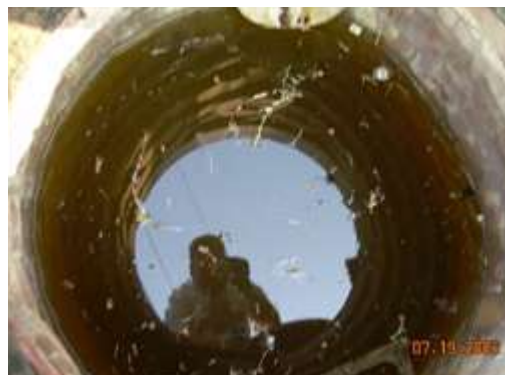
Top View

Chimney / Frame Adjustment ☒ Exists Material: **Brick** ☐ Parged Height: **6** (in.)
Condition: ☒ Sound ☐ Cracked ☐ Root Intrusion ☐ Loose Brick ☐ Deteriorated
Infiltration: ☐ None ☒ **Joint** ☐ Cracks ☒ **Mortar** ☐ Roots ☐ Wall

Corbel Material: **Brick** ☐ Parged Type: **Concentric/Eccentric**
Condition: ☒ Sound ☐ Cracked ☐ Root Intrusion ☐ Loose Brick ☐ Deteriorated
Infiltration: ☐ None ☐ Joint ☐ Cracks ☒ **Mortar** ☐ Roots ☒ **Wall**

Adjustment and Cobrel infiltration.

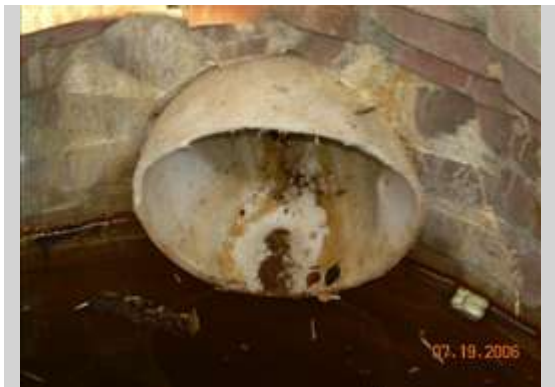
8 in. Circular Gravity Sewer
Pipe Out @ 12 O'Clock

Rod and Bar (Angled)

Pipe Material: **Unknown** ☒ Pipe Lined

Invert Depth: **2.58** (ft.) Flow Characteristics: **None**

Infiltration: **Evidence** Pipe Seal Cond: **Unknown**
